December 22, 2025
Project No. 20250119H001

Subject: Updated Critical Aquifer Recharge Area (CARA) Assessment Information
Emergence Whidbey
Whidbey Island, Washington

GEOTECHNICAL, INFILTRATION, AND
CRITICAL AREAS REPORT
EMERGENCE WHIDBEY
Campbell Road and Maxwelton Road
Island County, Washington

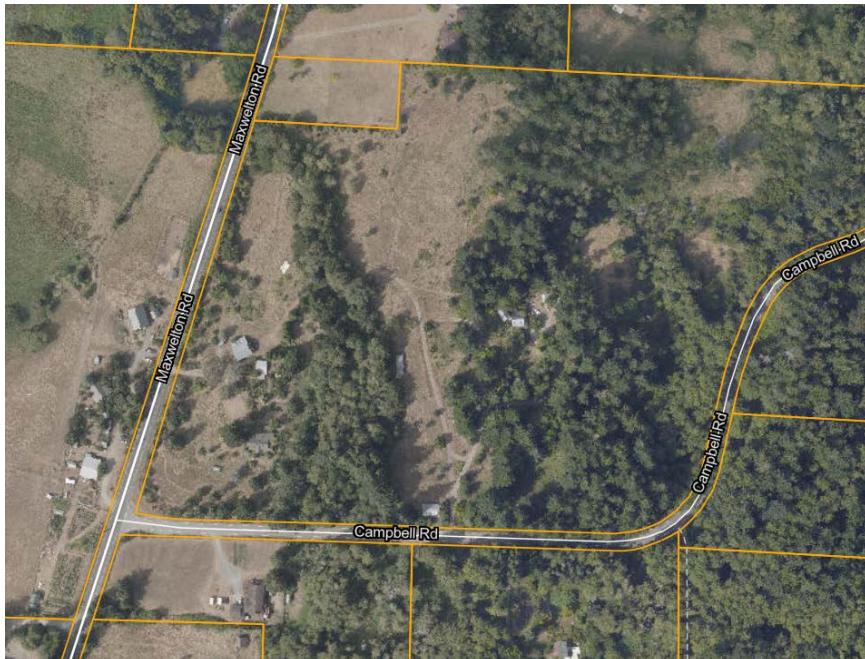
Plate 1: Aerial view of the site.

Plate 1 on the following page provides an aerial overview of the site while Plate 2 shows a ground level view of the general site conditions.

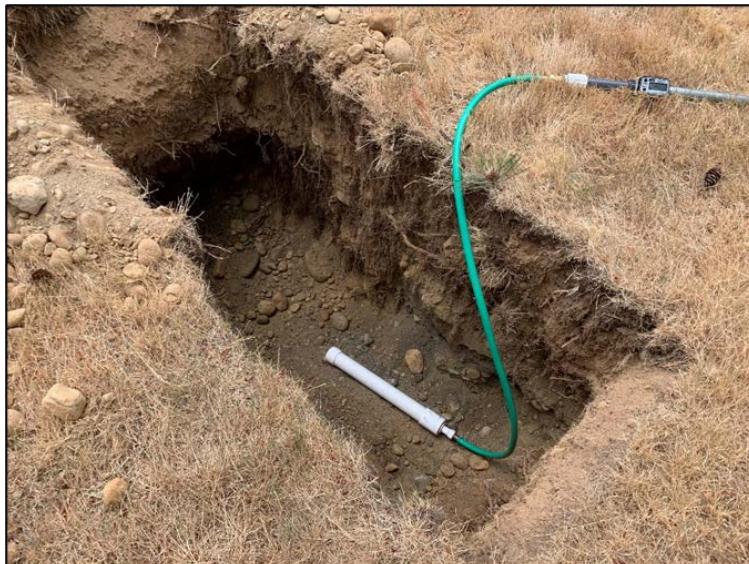
Plate 3: Typical infiltration testing setup.

- A test pit was excavated to the approximate design bottom of the proposed infiltration facility with a minimum bottom area of 12 square feet for each test location. Plate 3 below shows the infiltration test setup.
- The test pits were pre-soaked for six hours by maintaining a water level of at least 12 inches above the bottom of the pits.
- At the end of the pre-soak period, a flow meter was used to monitor the amount of water needed to maintain a constant head of 12 inches for at least one hour and until at least a point at which a constant volume of water per time unit was achieved.
- At the end of the constant head test, we measured the falling head infiltration rate by shutting off the water flow and recording the drop in water level over regular time intervals for one hour or until all the water was infiltrated.

The digital flow meter is visible in the upper right of the photo.

The field infiltration rate was then calculated based on the final measured volume per time unit and the bottom area of the pits. The results are summarized in Table 4 on the next page.

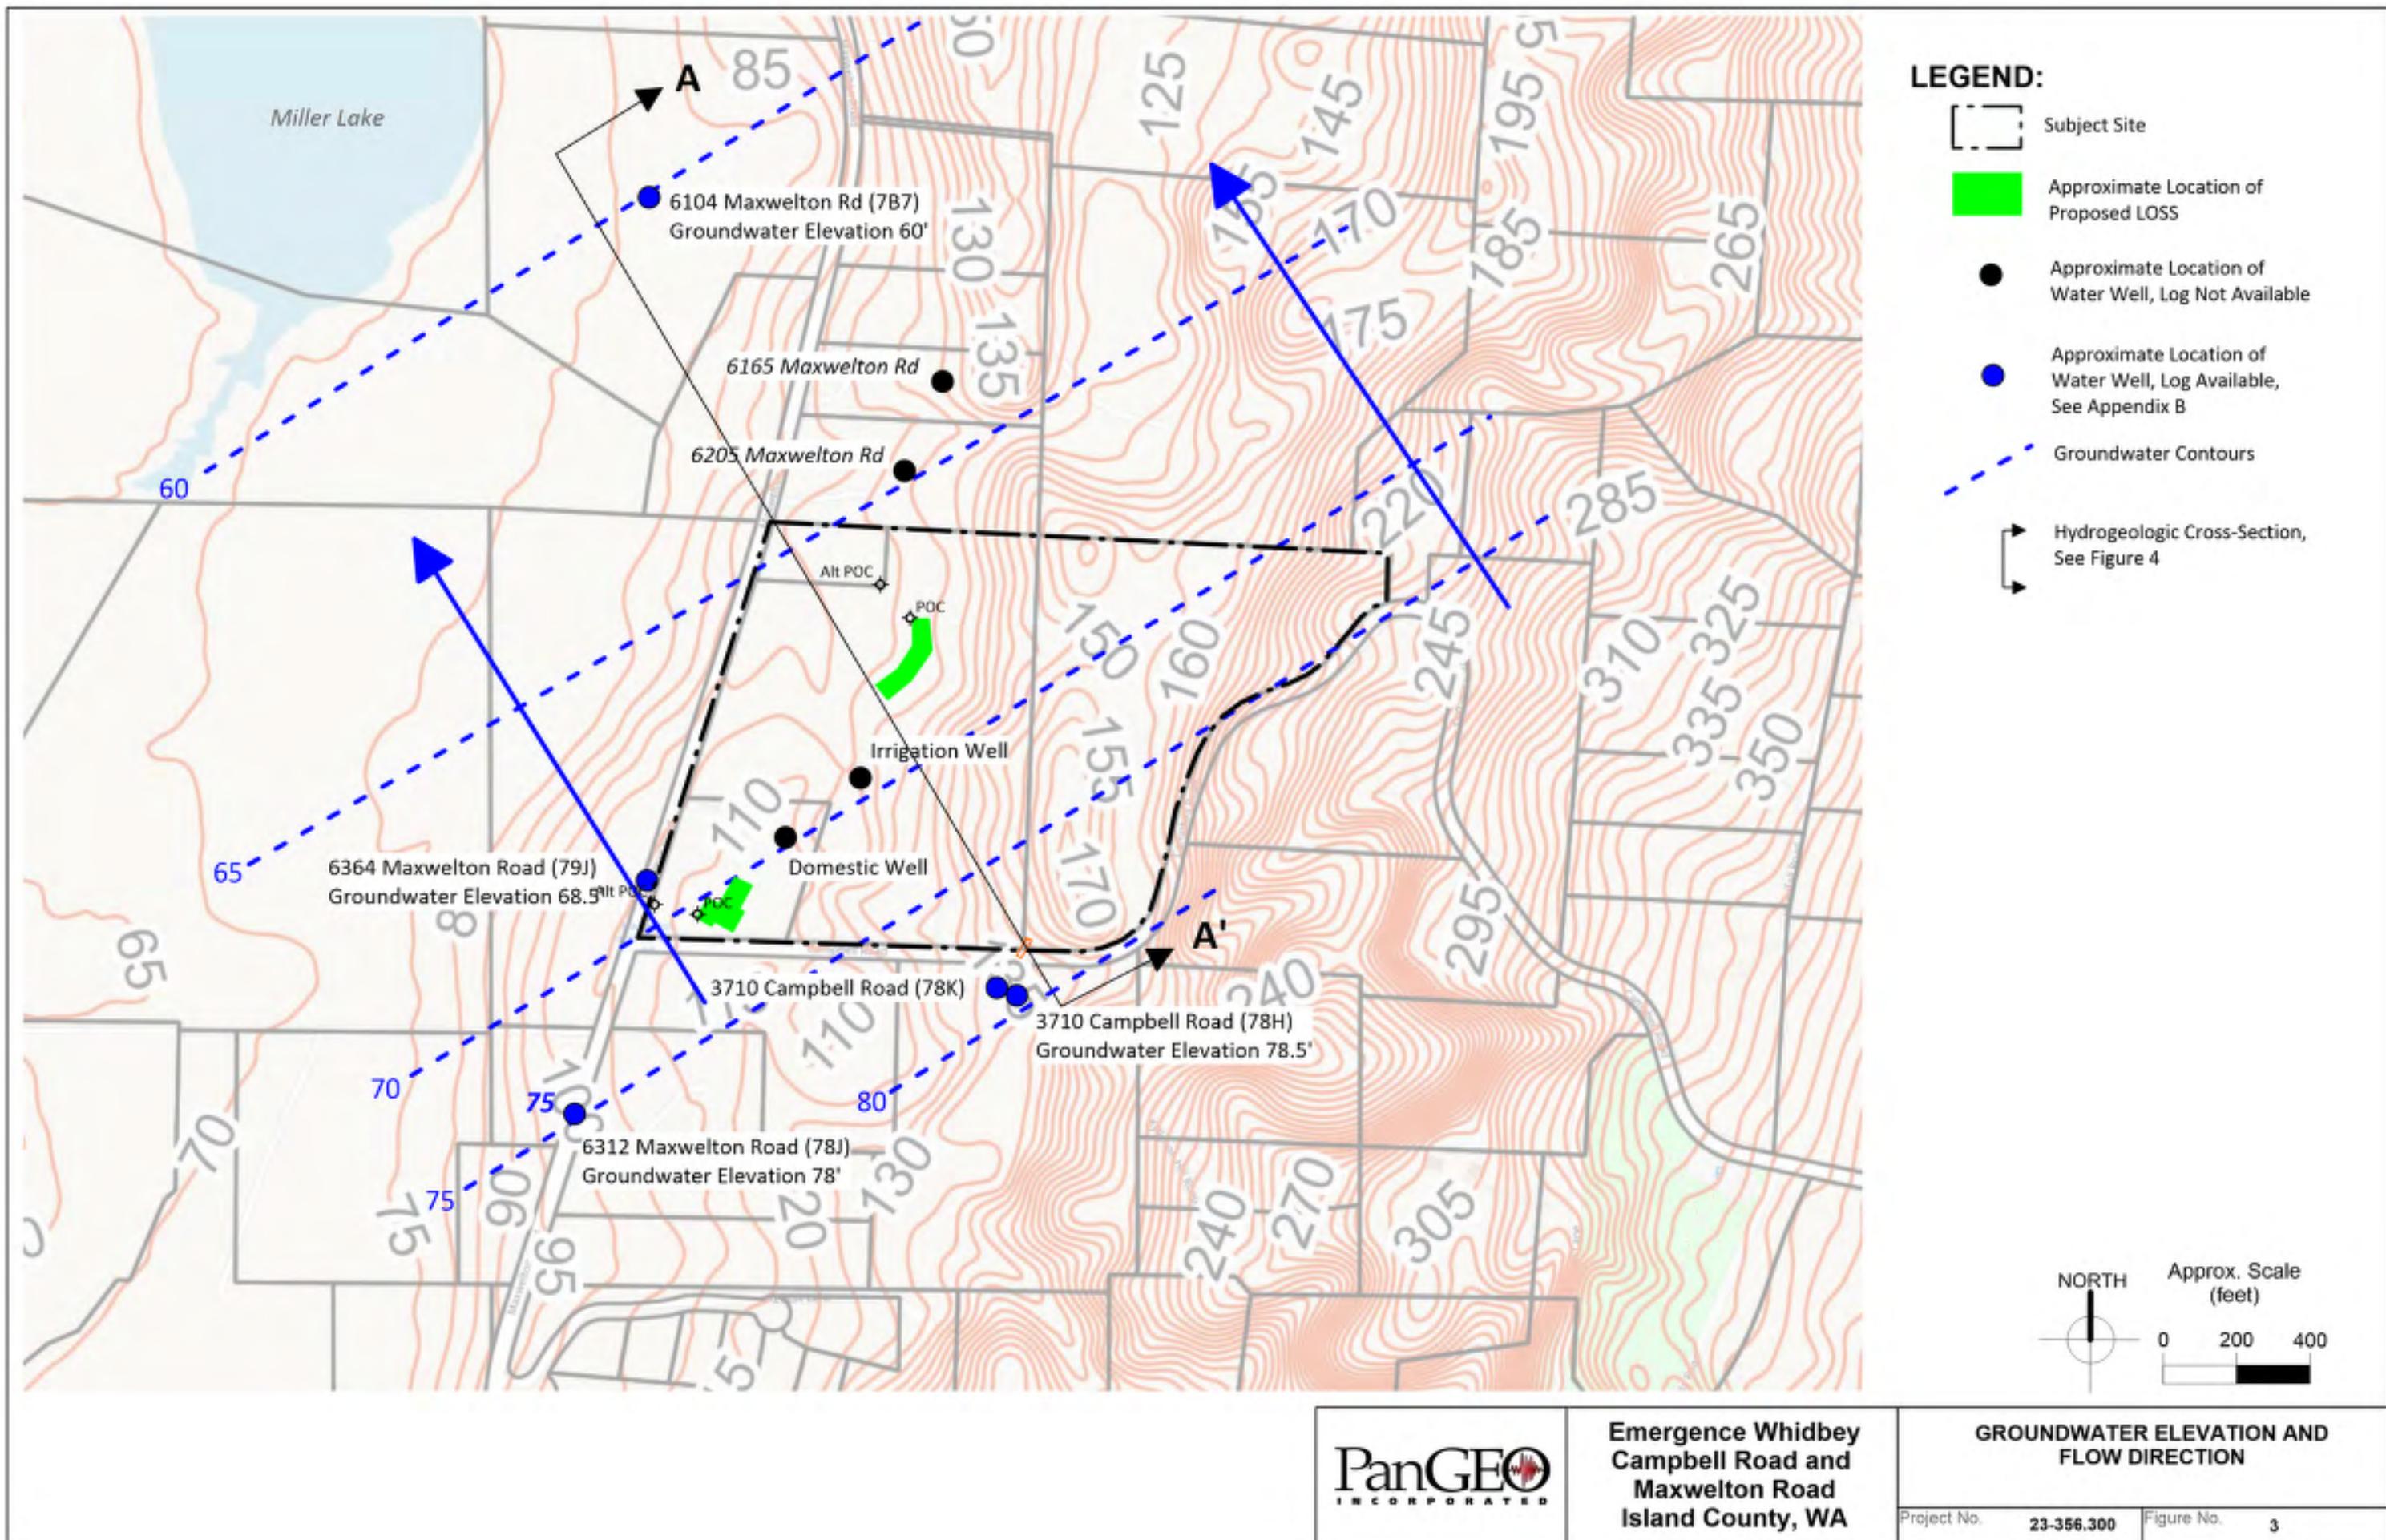
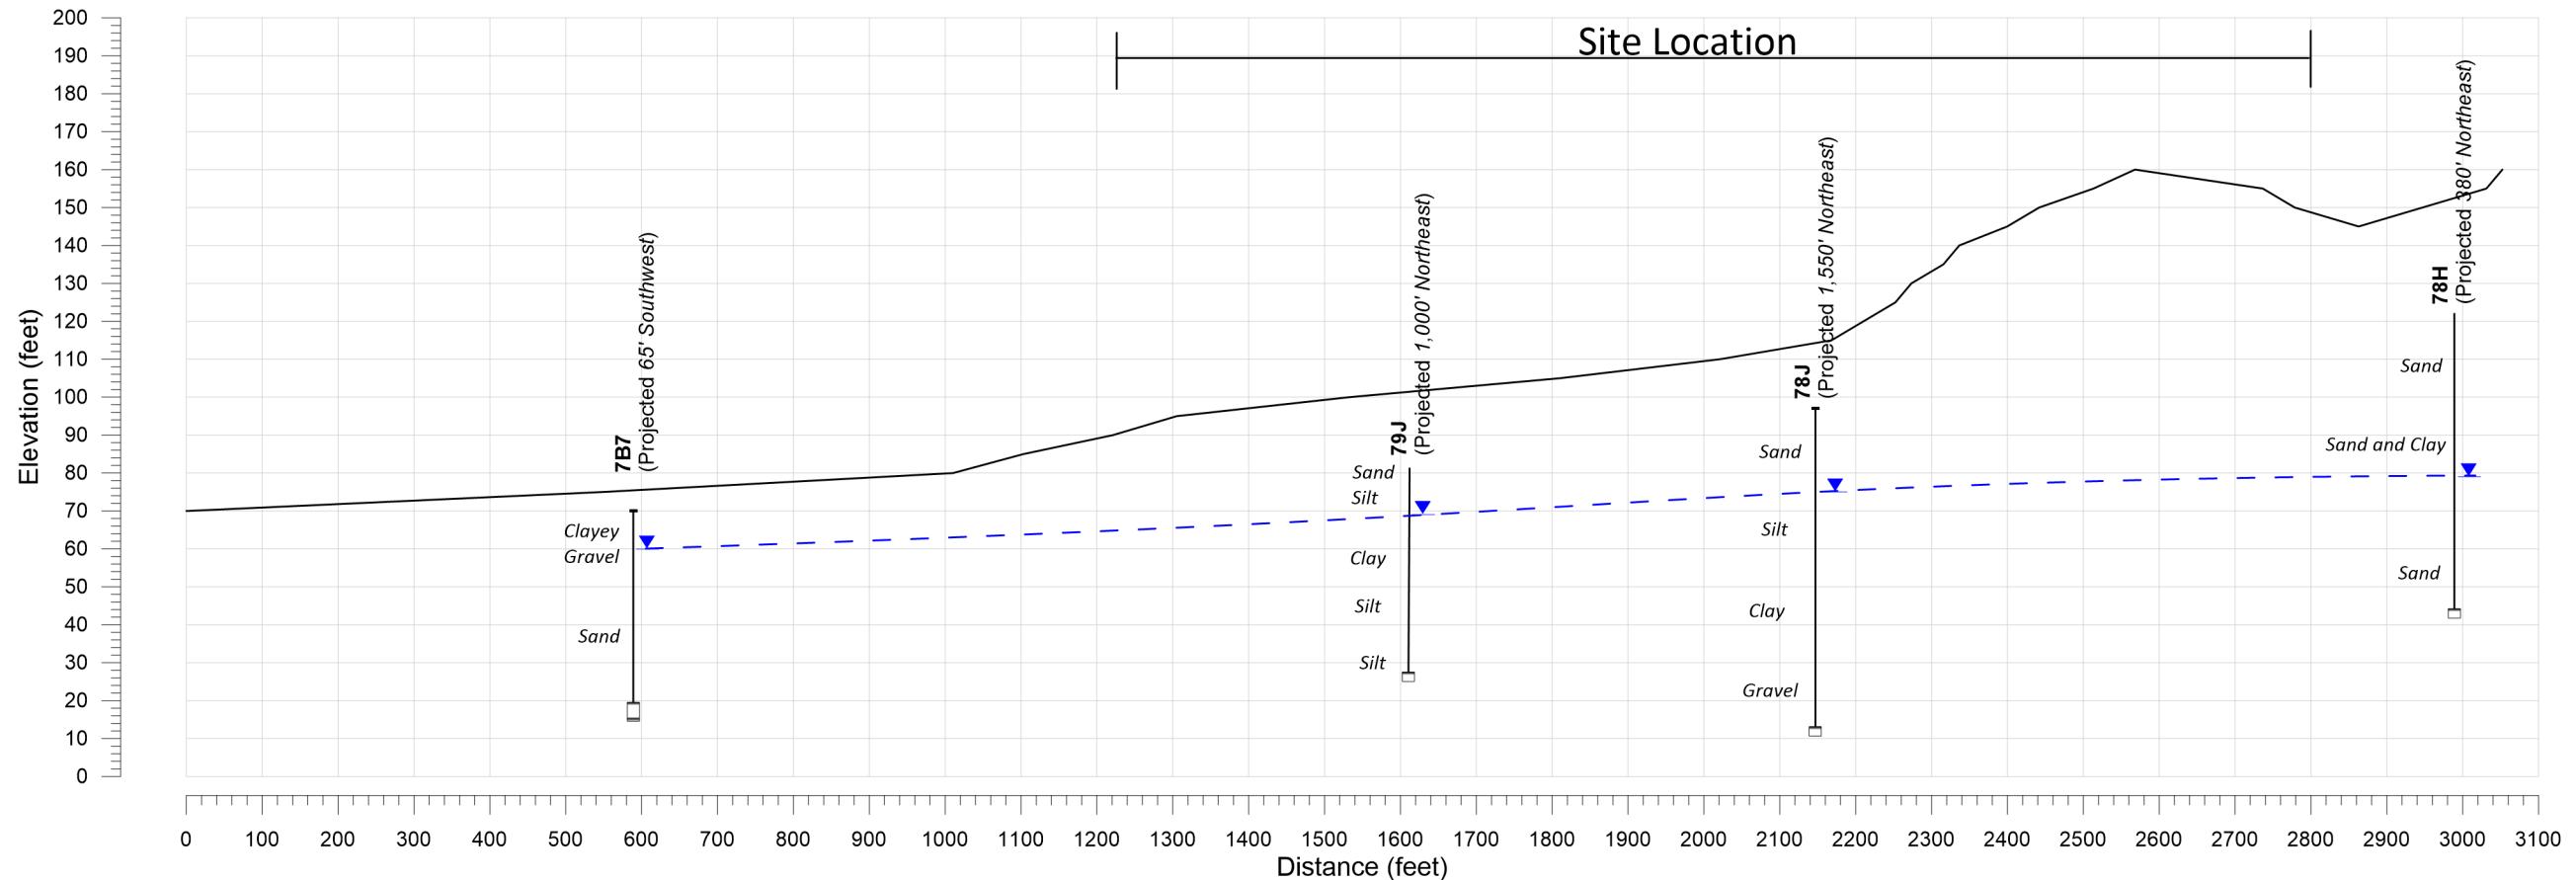
A (Northwest)

**A' (Southeast)**

Horizontal Scale 1"=250'
 Vertical Scale 1" = 25
 10X Vertical:Horizontal Exaggeration

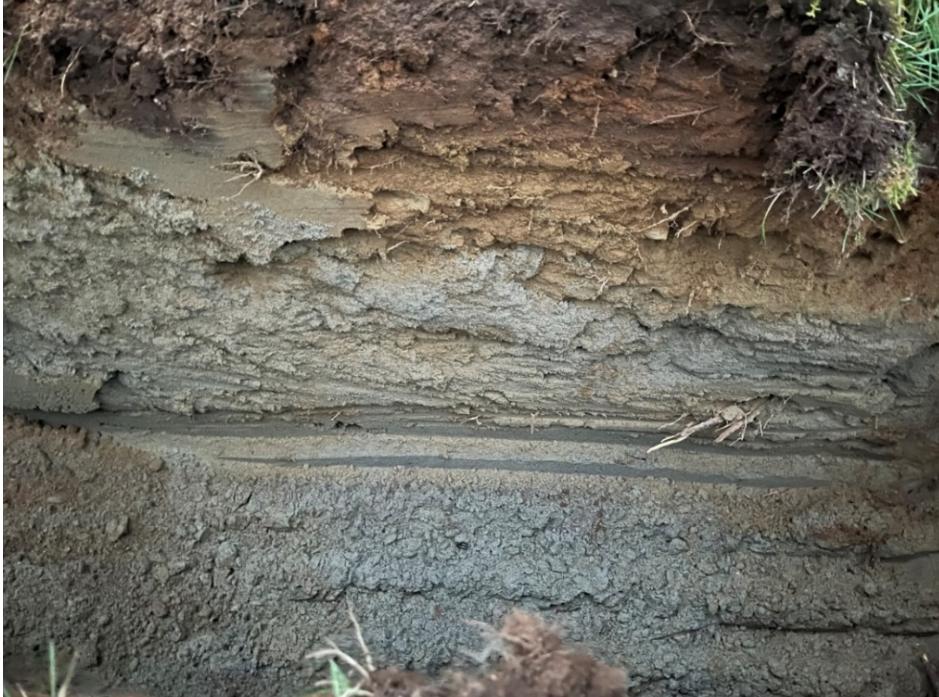
Test Pit No. PIT-1	
Location: 1253263, 363313 (Washington State Plane - North)	
Approximate ground surface elevation: 118 feet (NAVD88 – Island 2014 LiDAR Dataset)	
Depth (ft)	<u>Material Description</u>
0 - ½	[Topsoil] Loose, dark brown, silty sand with organics, moist
½ – 1½	[Alluvium] Medium dense, gray-brown, gravelly SAND trace silt; moist; trace roots
1½ – 5	[Alluvium] Medium dense, gray-brown, poorly graded GRAVEL with silt and sand; moist; trace roots
5 – 6	[Vashon Till – Qvt] Dense to very dense, gray, silty SAND; moist; trace roots • diamict (till-like) texture

Image of PIT-1 at approximately 5 feet below the existing ground surface. Groundwater seepage was not observed at the time of our excavation.	
Logged by: J. Meissner

At the location of PIT-1, the test was performed about one foot above a relatively hydraulically restrictive layer of Vashon till which resulted in a low design infiltration rate. At the location of PIT-2, we observed residual water from the test was observed mounding on less permeable soil layers, which also resulted in a low design infiltration rate.

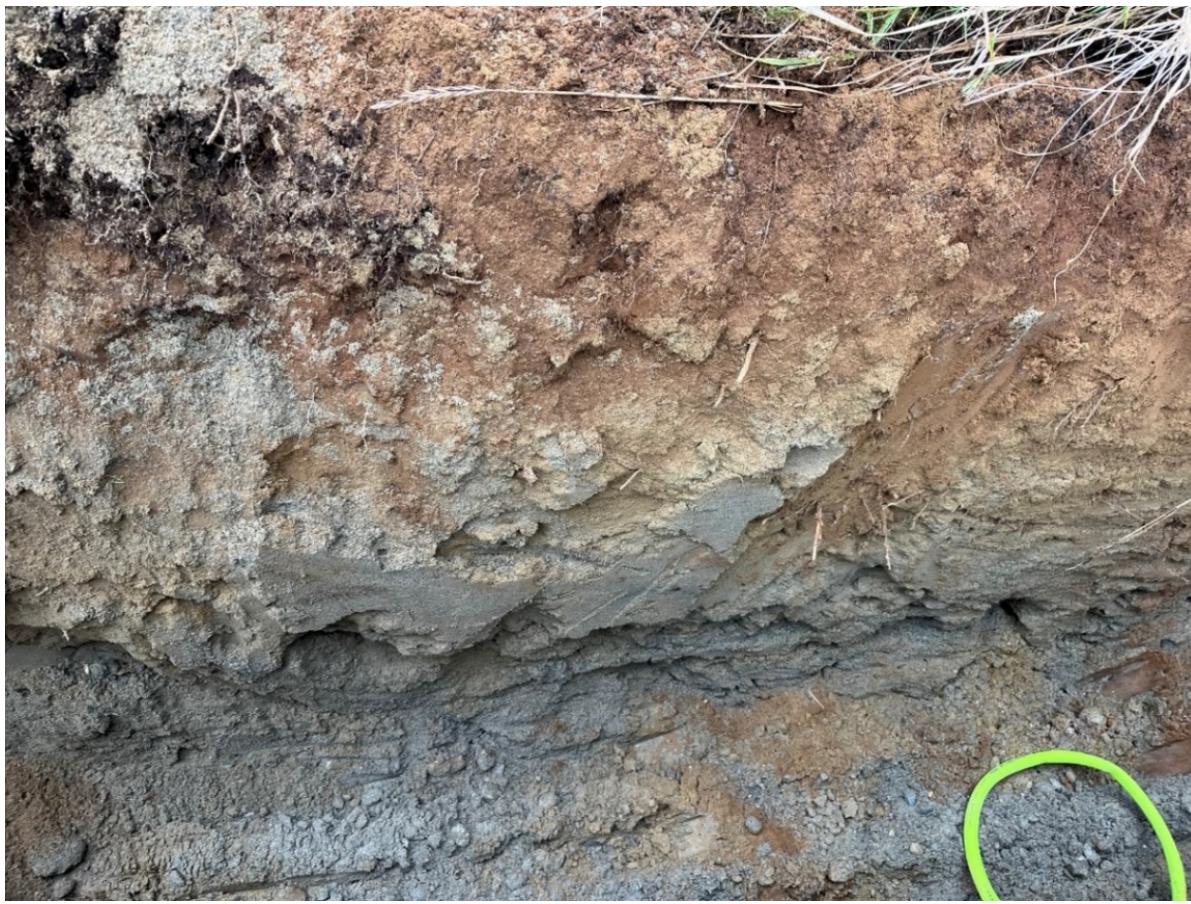
<u>Depth (ft)</u>	<u>Material Description</u>
0 - 1/2	[Topsoil] Loose, dark brown, silty sand with organics, moist
1/2 – 1 1/2	[Weathered Advance Outwash – Qva] Medium dense gray-brown gravelly SAND trace silt; moist; trace roots
1 1/2 – 8	[Advance Outwash - Qva] Medium dense, gray, poorly graded SAND with gravel; moist; trace roots

Image of PIT-2 at approximately 4 feet below the existing ground surface. Groundwater seepage was observed at approximately 7-8 feet during over-excavation.

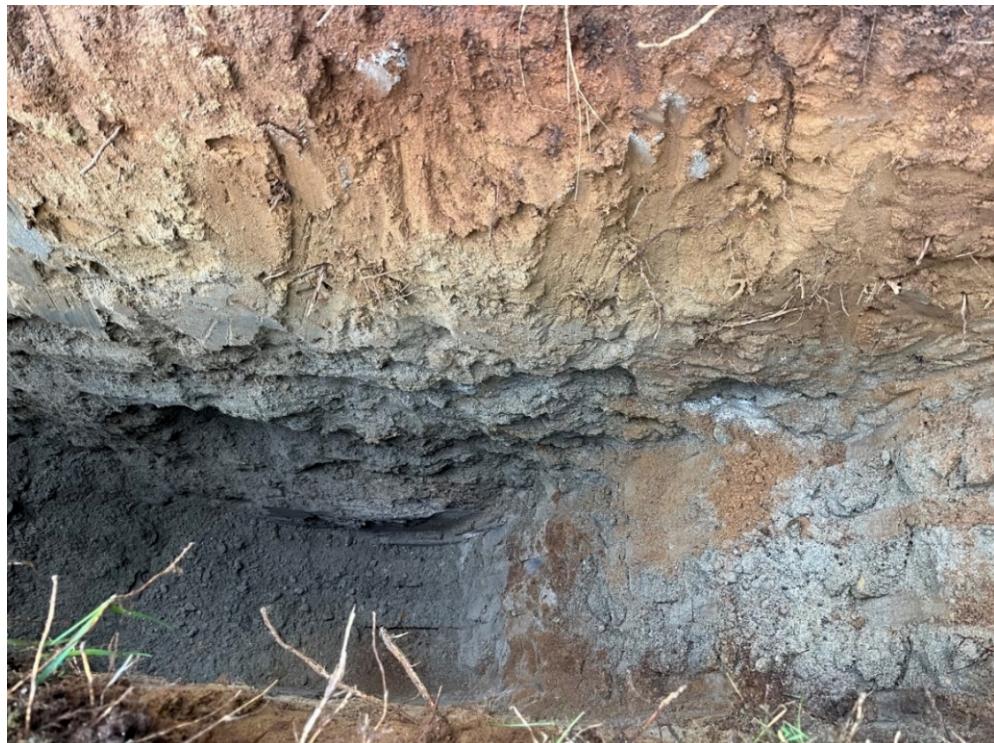
<u>Depth (ft)</u>	<u>Material Description</u>
0 - ½	[Topsoil] Loose, dark brown, silty sand with organics, moist
½ – 2	[Weathered Advance Outwash – Qva] Medium dense gray-brown gravelly SAND trace silt; moist; trace roots; trace organics
2 – 7	[Advance Outwash - Qva] Medium dense, gray, poorly graded SAND with gravel; moist; trace roots -- At 7 feet becomes with silt -- Diamict (till-like) texture

Image of PIT-3 at approximately 4 feet below the existing ground surface. Groundwater seepage was not encountered at the time of our excavation

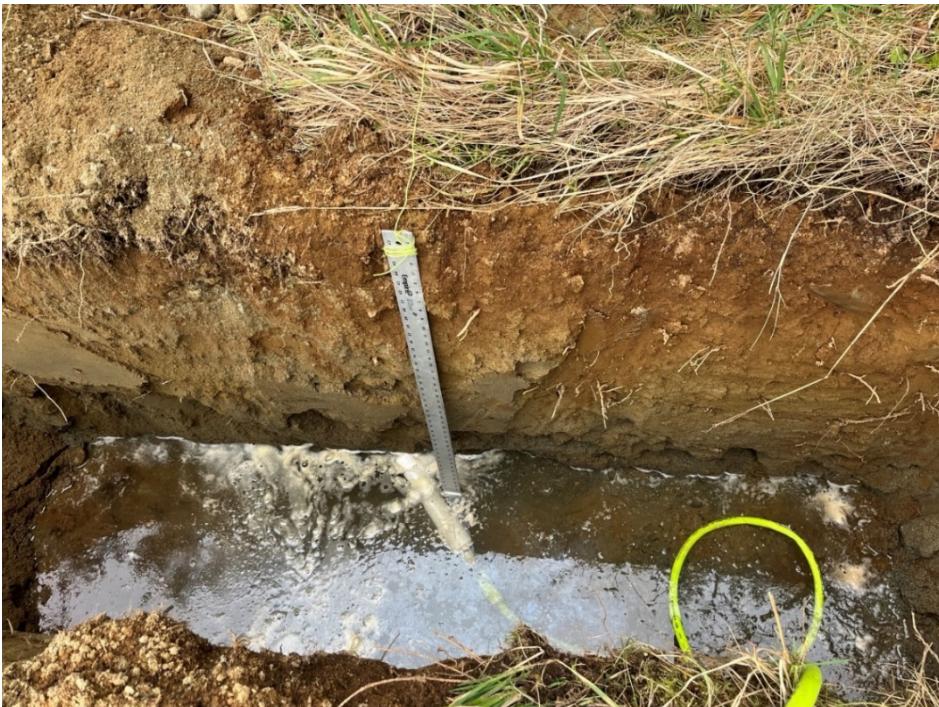
Test Pit No. PIT-4	
Location: 1253118, 362743 (Washington State Plane - North)	
Approximate ground surface elevation: 121 feet (NAVD88 – Island 2014 LiDAR Dataset)	
Depth (ft)	<u>Material Description</u>
0 - 1/2	[Topsoil] Loose, dark brown, silty sand with organics, moist
1/2 - 2 1/2	[Weathered Advance Outwash – Qva] Medium dense, brown, gravelly SAND; moist; trace roots
2 1/2 - 8	[Advance Outwash - Qva] Medium dense, gray-brown, poorly graded SAND with silt and gravel; moist; trace roots -- At 7 feet becomes silty and dense

Image of soils encountered approximately 4 feet below the existing ground surface during infiltration testing. Groundwater seepage was not encountered during excavation	
Logged by: J. Meissner

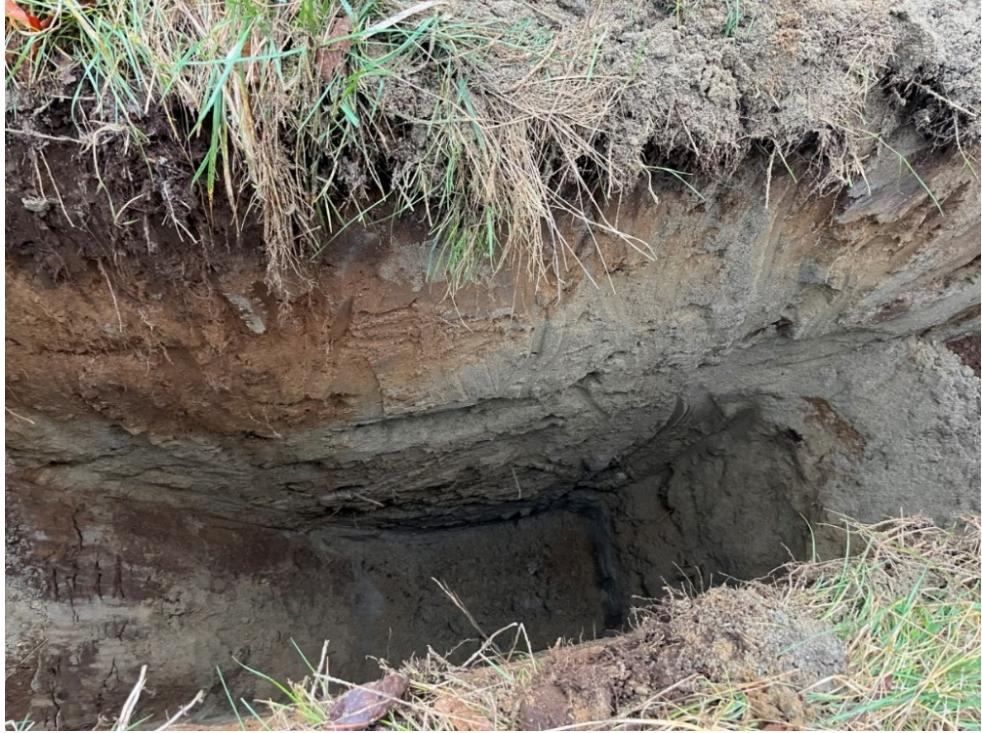
Test Pit No. PIT-5	
Location: 1253055, 362524 (Washington State Plane - North)	
Approximate ground surface elevation: 123 feet (NAVD88 – Island 2014 LiDAR Dataset)	
Depth (ft)	<u>Material Description</u>
0 – ¾	[Topsoil] Loose, dark brown, gravelly, silty SAND; moist; roots; organics
¾ – 2½	[Weathered Advance Outwash – Qva] Medium dense, gray-brown, poorly graded gravelly SAND trace silt; moist; trace roots
2½ – 8	[Advance Outwash - Qva] Medium dense to dense, gray-brown, poorly graded SAND; moist; trace roots; -- Becomes gray and gravelly at about 7 feet

Image of PIT-5 at approximately 8 feet below the existing ground surface. Groundwater seepage was not encountered at the time of our excavation	
Logged by: J. Meissner

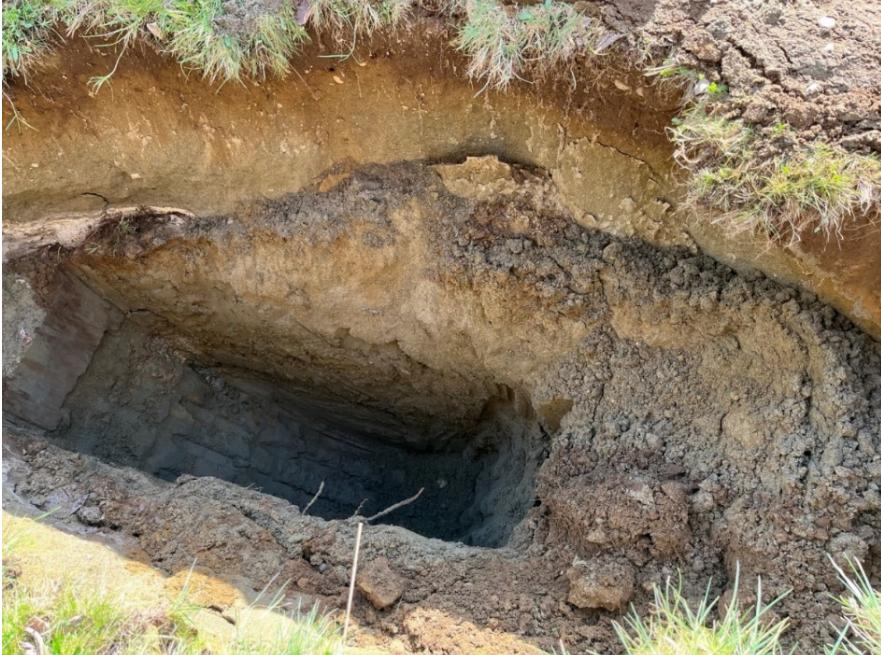
Test Pit No. PIT-6	
Location: 1252570, 362658 (Washington State Plane - North)	
Approximate ground surface elevation: 110 feet (NAVD88 – Island 2014 LiDAR Dataset)	
Depth (ft)	<u>Material Description</u>
0 – ½	[Topsoil] Loose, dark brown, silty SAND; moist; roots
½ – 2½	[Weathered Advance Outwash – Qva] Medium loose to medium dense, gray-brown, poorly graded gravelly SAND trace silt; moist; trace roots
2½ – 8	[Advance Outwash - Qva] Medium dense, gray, poorly graded SAND with gravel; moist; trace roots -- Gravel lenses observed at below five feet

Image of PIT-6 at approximately 8 feet below the existing ground surface. Groundwater seepage was not encountered at the time of our excavation	
Logged by: J. Meissner

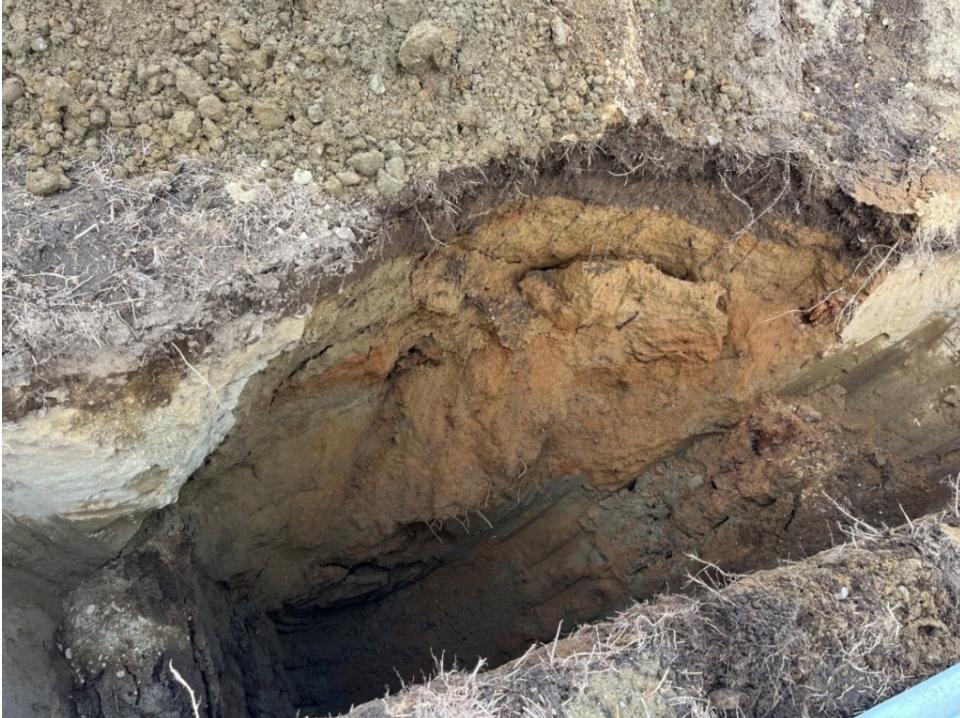
Test Pit No. PIT-7	
Location: 47.72932, -122.25046 (WGS84)	
Approximate ground surface elevation: 397 feet (NAVD88)	
Depth (ft)	<u>Material Description</u>
0 – ¾	[Topsoil] Loose, brown, gravelly silty SAND; moist; roots; trace debris; organics
¾ – 4	[Weathered Advance Outwash – Qva] Medium dense, gray-brown to red-brown, gravelly SAND trace silt; moist; trace roots; weathered; iron oxide staining
4 – 8	[Advance Outwash – Qva] Loose to medium dense, gray to gray-brown, poorly graded SAND with silt and gravel; moist; trace roots.

Image of PIT-7 at approximately 8 feet below the existing ground surface. Groundwater seepage was not encountered at the time of our excavation.	
Logged by: J. Meissner

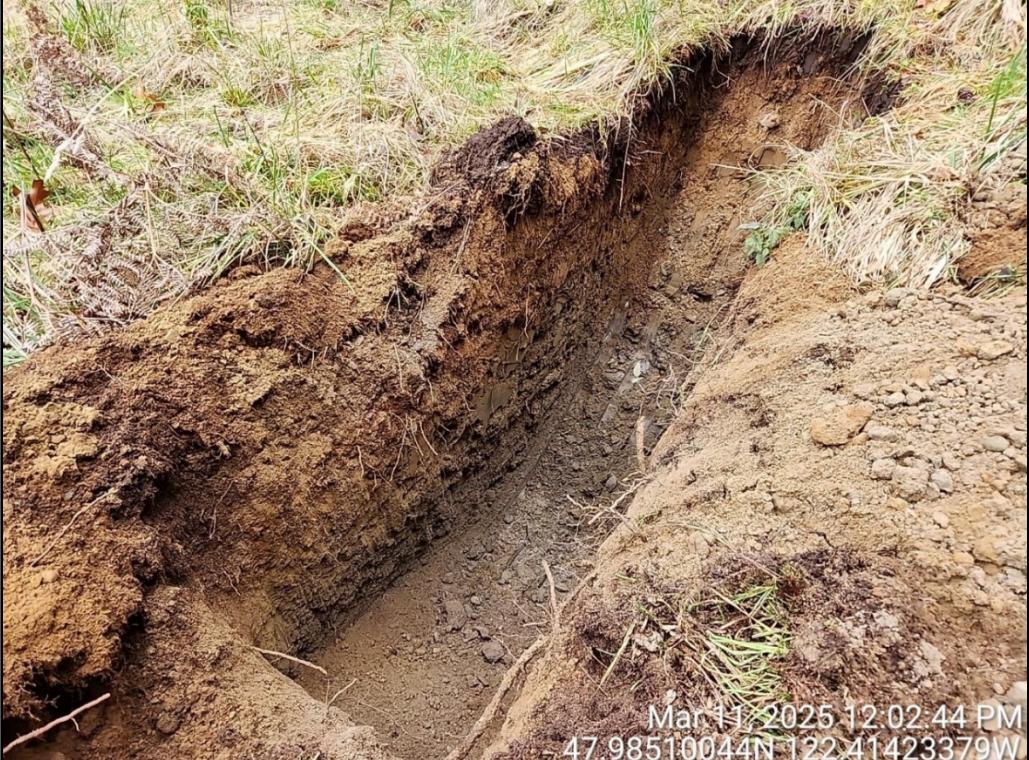
Test Pit No. TP-1	
Location: 1253311, 363325 (Washington State Plane - North)	
Approximate ground surface elevation: 126 feet (NAVD88 – Island 2014 LiDAR Dataset)	
Depth (ft)	<u>Material Description</u>
0 - ½	[Topsoil] Loose, dark brown, silty sand with organics, moist
½ – 2	[Weathered Vashon Till - Qvt] Loose to medium dense, orange-brown, silty fine SAND; trace gravel, scattered roots and organics; disturbed texture, iron-oxide staining; moist
2 – 6	[Vashon Till - Qvt] Dense to very dense, orange-brown to gray-brown, silty fine to medium SAND with gravel, trace cobble; trace iron-oxide staining; moist -- Diamict (till-like) texture

<p>Mar 11, 2025 12:02:44 PM 47.98510044N 122.41423379W</p>	
Image of Test Pit TP-1 at approximately 6 feet below the existing ground surface at practical digging refusal. Groundwater seepage was not observed at the time of our excavation.	
Logged by: S. Scott

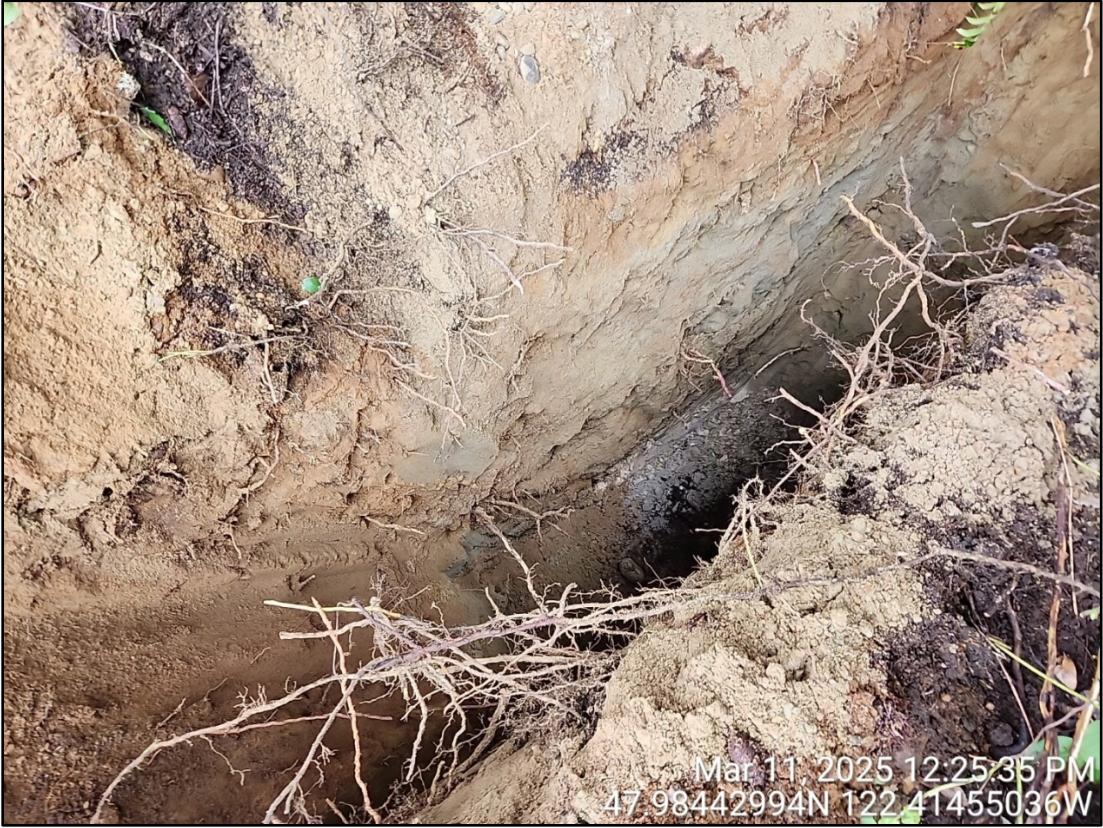
Test Pit No. TP-2	
Location: 1253274, 363067 (Washington State Plane - North)	
Approximate ground surface elevation: 124 feet (NAVD88 – Island 2014 LiDAR Dataset)	
Depth (ft)	<u>Material Description</u>
0 - ½	[Topsoil] Loose, dark brown, forest duff/organics, moist
½ – 6	[Weathered Advance Outwash - Qva] Medium dense, orange-brown to gray-brown, poorly-graded SAND with silt; trace gravel, scattered roots and organics; iron-oxide staining; moist
6 – 7	[Advance Outwash - Qva] Dense, gray-brown, silty fine to medium SAND with gravel; moist

<p>Mar 11, 2025 12:25:35 PM 47 98442994N 122 41455036W</p>	
Image of Test Pit TP-2 at approximately 7 feet below the existing ground surface at practical digging refusal. Groundwater seepage was not observed at the time of our excavation.	
Logged by: S.Scott

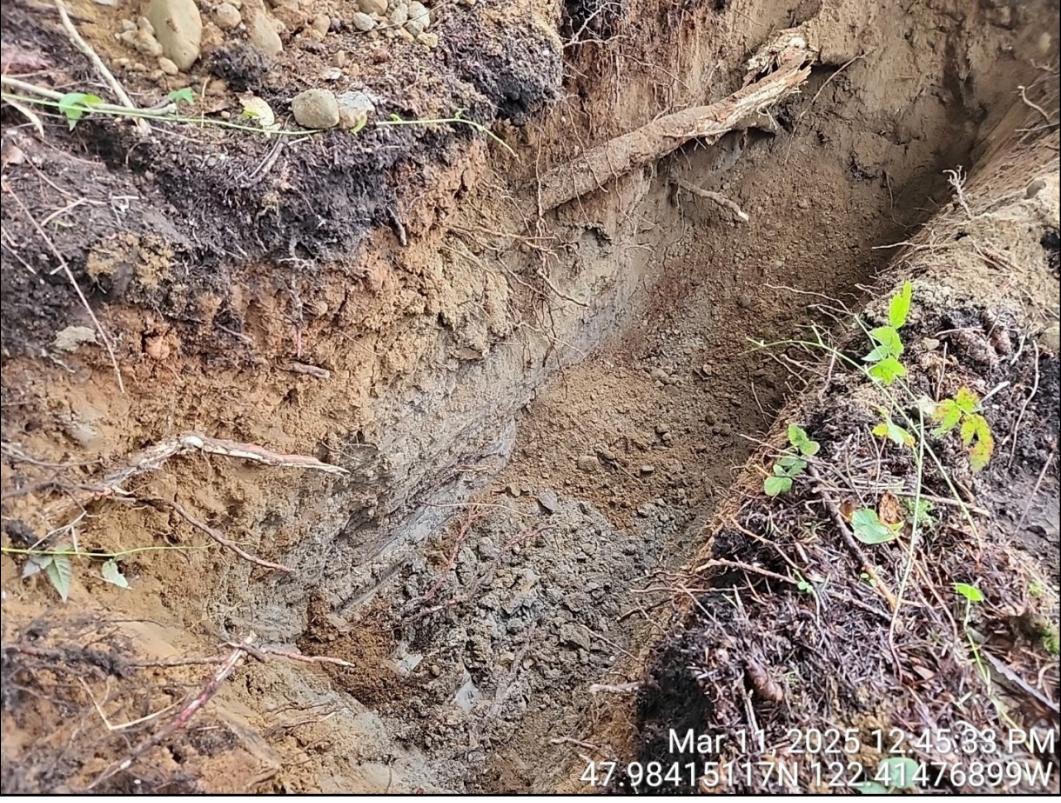
Test Pit No. TP-3	
Location: 1253199, 362986 (Washington State Plane - North)	
Approximate ground surface elevation: 123 feet (NAVD88 – Island 2014 LiDAR Dataset)	
Depth (ft)	<u>Material Description</u>
0 - 1/2	[Forest Duff] Loose, dark brown, silty sand with leaf litter and organics, moist
1/2 - 2	[Weathered Advance Outwash - Qva] Approximately 6 inches of forest duff above: loose to medium dense, orange-brown, silty fine SAND; trace gravel, roots and organics; iron-oxide staining; moist
2 - 4	[Advance Ourwash - Qva] Dense to very dense, gray-brown, poorly graded SAND with silt and gravel; moist

<p>Mar 11 2025 12:45:33 PM 47.98415117N 122.41476899W</p>	
Image of Test Pit TP-3 at approximately 4 feet below the existing ground surface at practical digging refusal. Groundwater seepage was not observed at the time of our excavation.	
Logged by: S. Scott

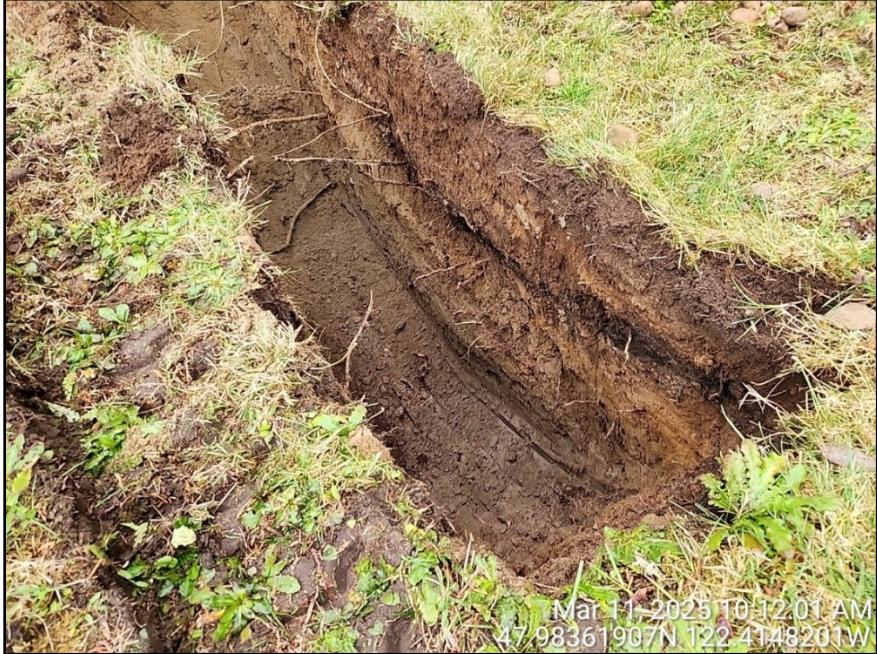
Test Pit No. TP-4	
Location: 1253141, 362776 (Washington State Plane - North)	
Approximate ground surface elevation: 129 feet (NAVD88 – Island 2014 LiDAR Dataset)	
Depth (ft)	<u>Material Description</u>
0 - ½	[Topsoil] Loose, dark brown, silty sand with organics, moist
½ - 3	[Weathered Advance Outwash – Qva] Medium dense, orange-brown, silty fine SAND; trace gravel, scattered roots and organics; disturbed texture, iron-oxide staining; moist -- Relic soil horizon approximately 3 feet inches below surface
3 - 6	[Advance OutwashAlluvium – Qal] Medium dense, orange-brown to gray-brown, poorly grades SAND with silt, trace gravel, scattered roots and organics; iron-oxide staining; moist -- Becomes dense to very dense at 5 feet

Image of Test Pit TP-4 at approximately 6 feet below the existing ground surface at practical digging refusal. Groundwater seepage was not observed at the time of our excavation.

- **Fill:** At the location of Test Pit TP-4, we encountered about two feet of loose silty fine sand containing organics debris that has a disturbed texture. Based on the disturbed texture and the presence of a buried topsoil horizon at the base of the layer, we classified this material as fill.

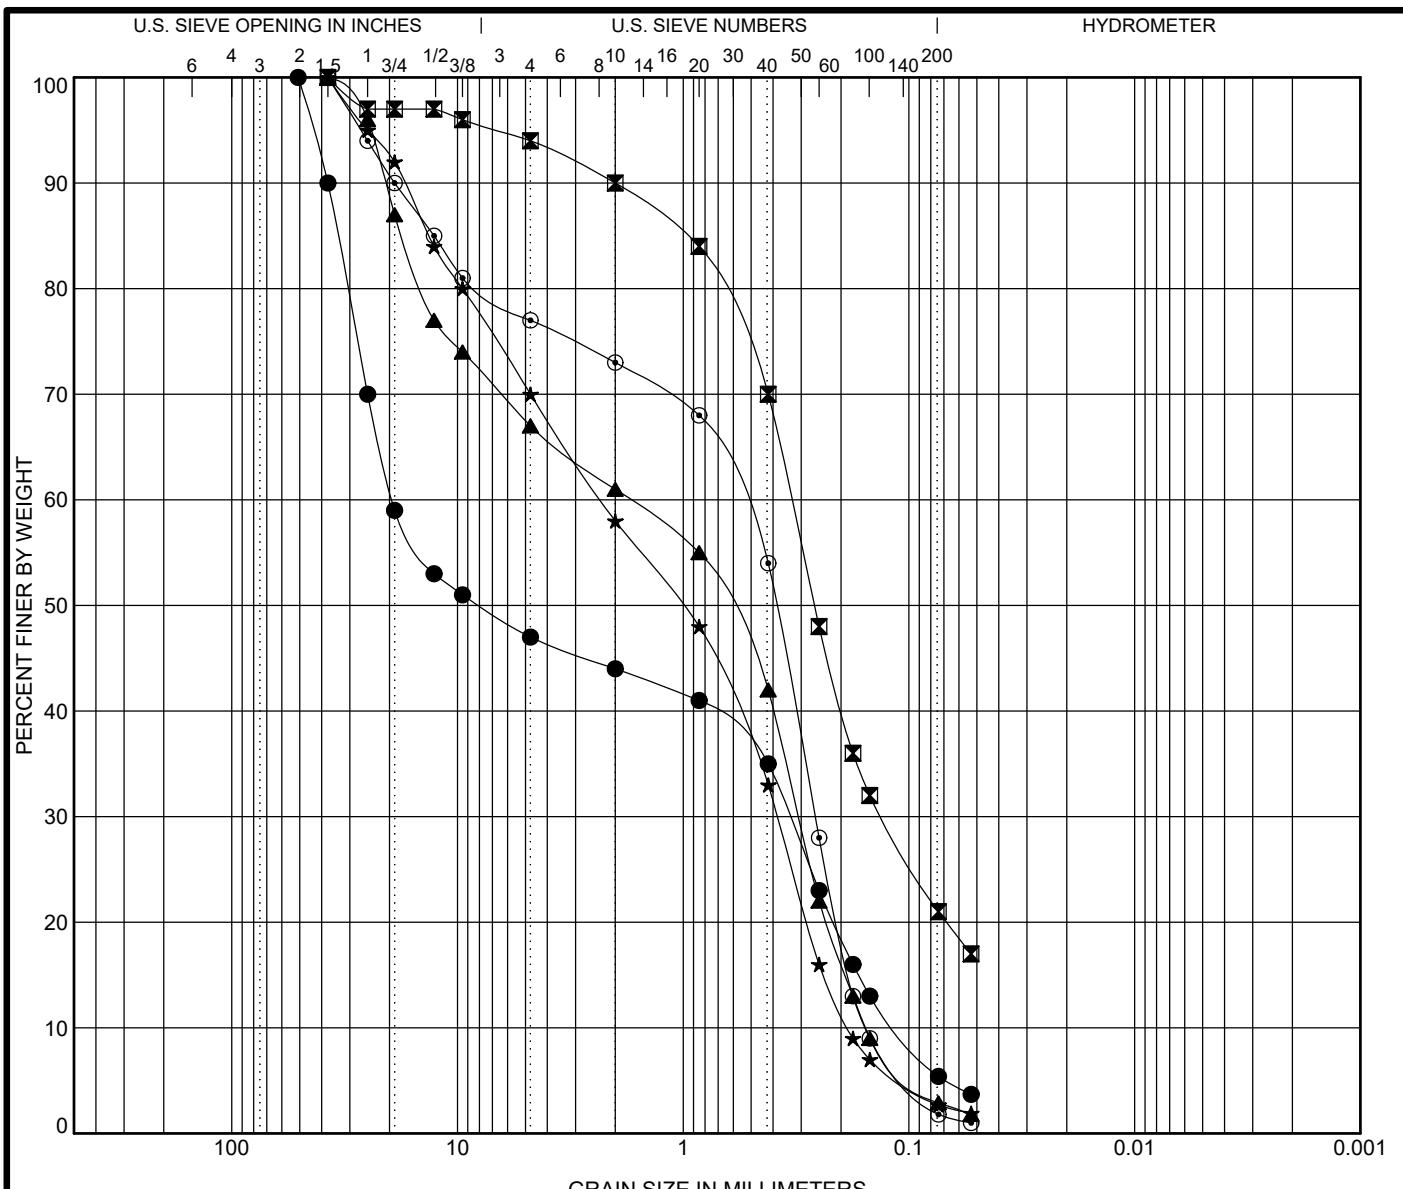
Figure
 C-1

Specimen Identification	Classification						LL	PL	PI	Cc	Cu
● PIT-1 @ 5.0 ft.	POORLY GRADED GRAVEL with SILT and SAND(GP-GM)									0.05	172.34
◻ PIT-1 @ 5.5 ft.	SILTY SAND(SM)										
▲ PIT-2 @ 4.0 ft.	POORLY GRADED SAND with GRAVEL(SP)									0.35	11.15
★ PIT-2 @ 8.0 ft.	POORLY GRADED SAND with GRAVEL(SP)									0.34	12.42
○ PIT-3 @ 4.0 ft.	POORLY GRADED SAND with GRAVEL(SP)									0.77	3.65
Specimen Identification	D100	D90	D60	D10	%Gravel	%Sand	%Silt	%Clay			
● PIT-1 5.0	50.8	37.5	19.48	0.113	53.0	41.5					5.5
◻ PIT-1 5.5	37.5	2	0.332		6.0	72.8					21.2
▲ PIT-2 4.0	37.5	20.82	1.734	0.156	33.0	64.0					3.0
★ PIT-2 8.0	37.5	17.18	2.31	0.186	30.0	67.2					2.8
○ PIT-3 4.0	37.5	19	0.568	0.156	23.0	75.1					1.9

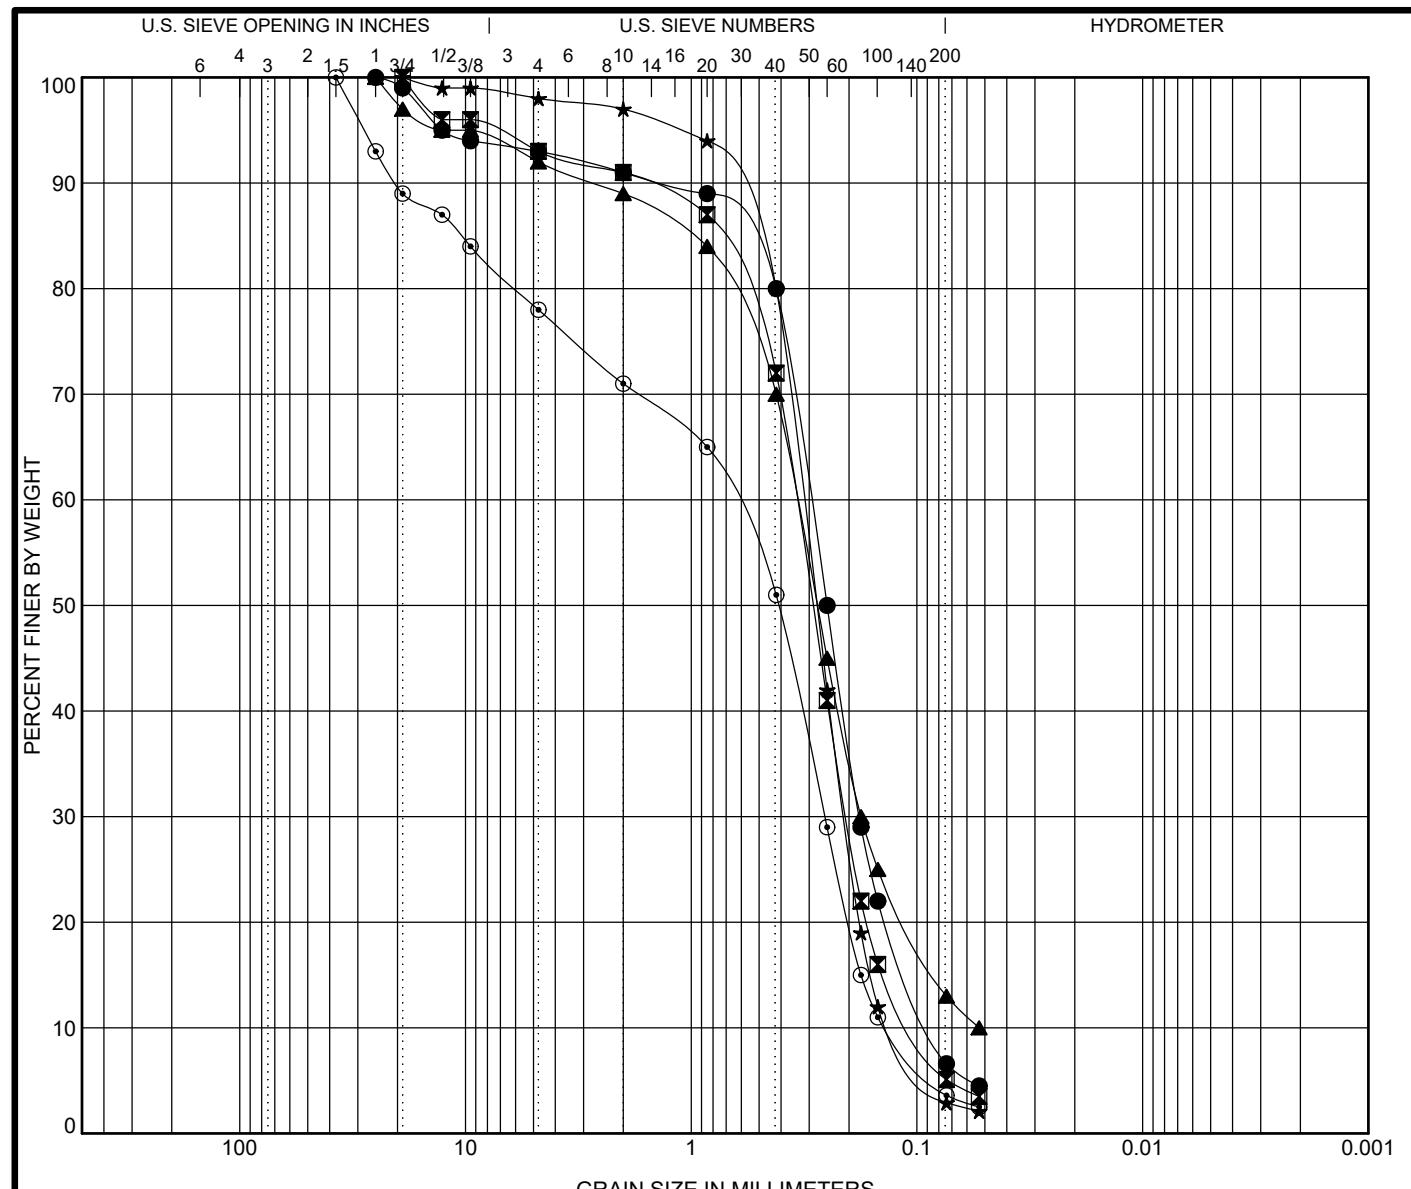
Figure
 C-2

Specimen Identification	Classification						LL	PL	PI	Cc	Cu
● PIT-3 @ 8.0 ft.	POORLY GRADED SAND with SILT(SP-SM)									1.26	3.44
☒ PIT-4 @ 4.0 ft.	POORLY GRADED SAND with SILT(SP-SM)									1.20	3.39
▲ PIT-4 @ 8.0 ft.	SILTY SAND(SM)									1.73	6.44
★ PIT-5 @ 8.0 ft.	POORLY GRADED SAND(SP)									1.07	2.50
○ PIT-6 @ 8.0 ft.	POORLY GRADED SAND with GRAVEL(SP)									0.73	4.87
Specimen Identification	D100	D90	D60	D10	%Gravel	%Sand	%Silt	%Clay			
● PIT-3 8.0	25	1.304	0.297	0.086	7.0	86.1					6.9
☒ PIT-4 4.0	19	1.615	0.344	0.101	7.0	87.7					5.3
▲ PIT-4 8.0	25	2.668	0.341	0.053	8.0	78.8					13.2
★ PIT-5 8.0	19	0.695	0.32	0.128	2.0	94.9					3.1
○ PIT-6 8.0	37.5	20.349	0.661	0.136	22.0	74.3					3.7
