December 22, 2025
Project No. 20250119H001

Subject: Updated Critical Aquifer Recharge Area (CARA) Assessment Information
Emergence Whidbey
Whidbey Island, Washington

GEOTECHNICAL, INFILTRATION, AND
CRITICAL AREAS REPORT
EMERGENCE WHIDBEY
Campbell Road and Maxwelton Road
Island County, Washington

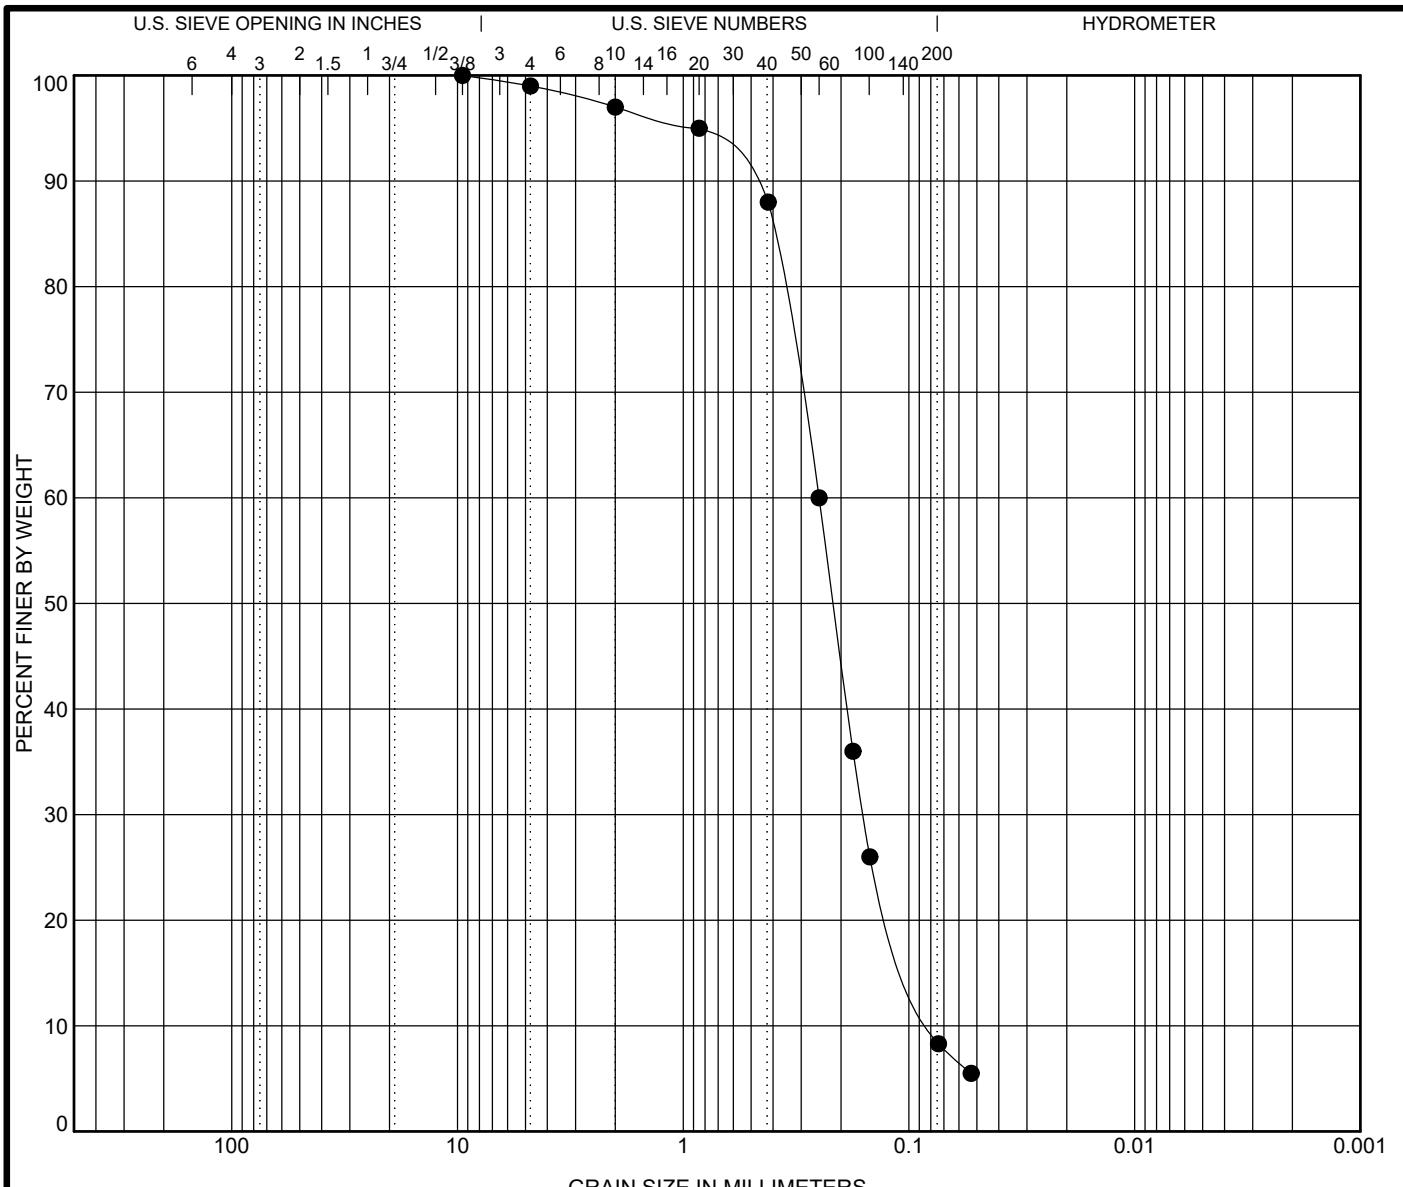
Specimen Identification	Classification						LL	PL	PI	Cc	Cu
PIT-7 @ 8.0 ft.	POORLY GRADED SAND with SILT(SP-SM)									1.29	3.16
Specimen Identification	D100	D90	D60	D10	%Gravel	%Sand	%Silt	%Clay			
PIT-7 8.0	9.5	0.514	0.25	0.079	1.0	90.4					8.6

GRAIN SIZE DISTRIBUTION
